USE OF RPAS (DRONES) FOR OLD BRIDGES INSPECTION: APPLICATION ON PONTE OLVEIRA BRIDGE

*Rodríguez Elizalde, Rubén

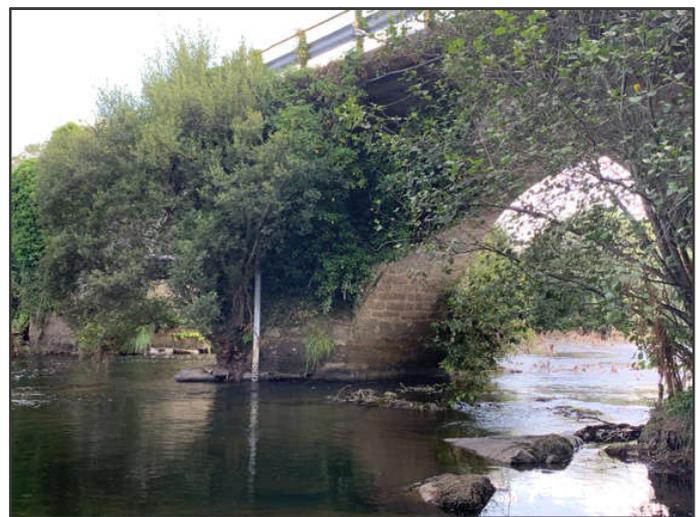
Fig. 3: Intermediate arch vault of the Ponte Oliveira Bridge with abundant vegetation on the cutwaters, in a photograph taken by the drone (photo by the author).

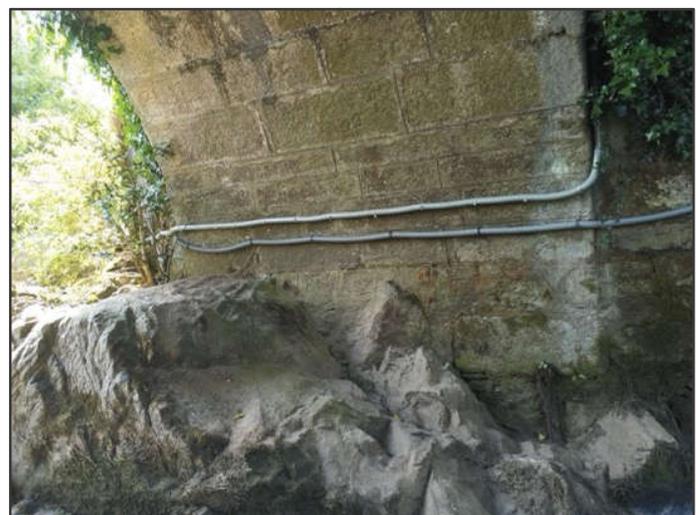
Once the inspection had begun, the first thing was, without a doubt, to analyze the foundation. The drone allowed to approach it (Fig. 7). Thus, we have been able to verify that one of the abutments of the bridge rests on a granite base identical to the granite that makes up the ashlar of the bridge. We were also able to partially observe the foundation of the first pier (listing the piers in a south-north direction). We could not see the rest of the foundations because they were submerged, under the waters of the Xallas River.

The visible foundation and the start of the structure (piers and abutments) were in good condition. (Fig. 7). The drone was effective in being able to carry out a detailed visual inspection of the foundation (at least the visible part). In addition, with the incorporated technology, the aircraft can estimate the typology, the dimensions of the foundation element and help other important operations in structures of this type: approximate estimation of the type of terrain, estimation of the longitudinal profile of the riverbed, estimation of the cross-section upstream and downstream of the bridge, determination of the degree of cleanliness of the channel and setting out of the drag elements in it. Thanks to this, we were able to obtain the necessary data to later make a plan of the bridge (Fig. 4) After analyzing the foundation, we continue with the structural inspection of the rest of the elements. One of the most interesting points was the four arch vaults intrados. The vaults intrados are interesting because of the injuries found on them and it is also interesting because of its inaccessibility. In order to carry out a complete visual inspection of any intrados we would need to enter the river, swimming or sailing on a boat. But the level of approximation can in no case reach as far as the drone can go. The constitutive granite of the monument presents, in the intrados, deteriorations due to the synergy of actions of a diverse nature: phenomena of a chemical nature and phenomena of a biological nature. Thus, we observed the formation of various black crusts, especially in the ashlar of the outer zone (Fig. 9 y Fig. 10), presumably linked to the action of contaminating agents and especially to the humidity of the river. We know that this bridge has been restored several times: the use of lime mortar in the last restoration could have increased this damage. Along with the dark crusts we could see spots of dirt (Fig. 9 y Fig. 10). This damage is also characteristic of structural elements exposed to high humidity. These stains result from the joint action of water (humidity), the crystallization of salts provided by contaminating agents and granite masonry (Sweevers & Van Grieken, 1992). The inspection allowed us to locate efflorescence in the central area of the intrados of the vault (Fig. 9 y Fig. 10). Efflorescence's usually appear around areas where there is a high concentration of humidity as well. Obviously, a river like the Xallas River produces this high concentration of humidity. To understand it, we must understand the original construction of the bridge. This bridge was built with large, padded granite ashlar (without mortar in the joints), since that is how ancient bridges were built. Unfortunately, this padding cannot be properly appreciated in many areas due to the mortar used (Fig. 7, Fig. 8, Fig. 9, Fig. 10, Fig. 11 and Fig. 12), to fill the joints, in the subsequent actions.

Fig. 7: Rocky substrate that serves as the foundation for the southern abutment of the Ponte Oliveira Bridge (photo taken with the drone).

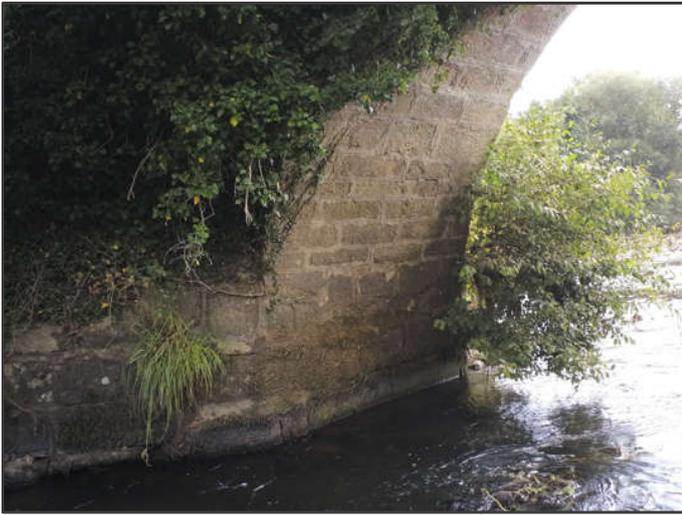
Fig. 8: Start of the third pier (counting from the south bridge abutment), and its corresponding cutwater, on the Ponte Olveira bridge (photo taken with the drone).

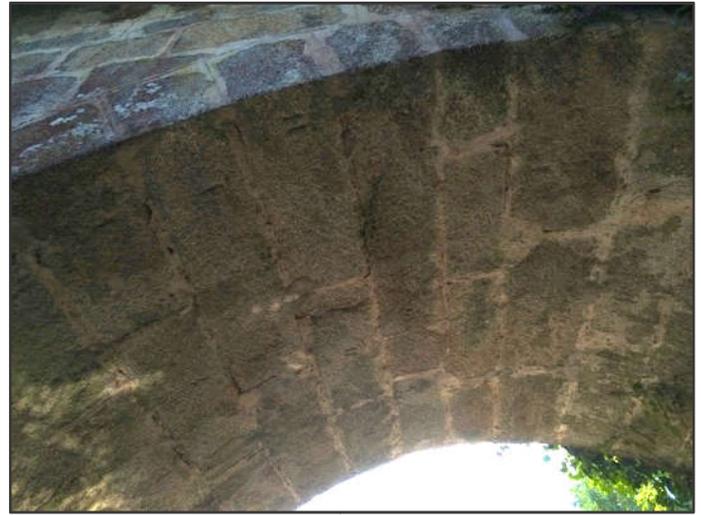
Fig. 11: Image captured with the quadcopter drone in the upper part intrados of the second arch vault, where in addition to the previous injuries we can see mortar deterioration (photograph by the author).

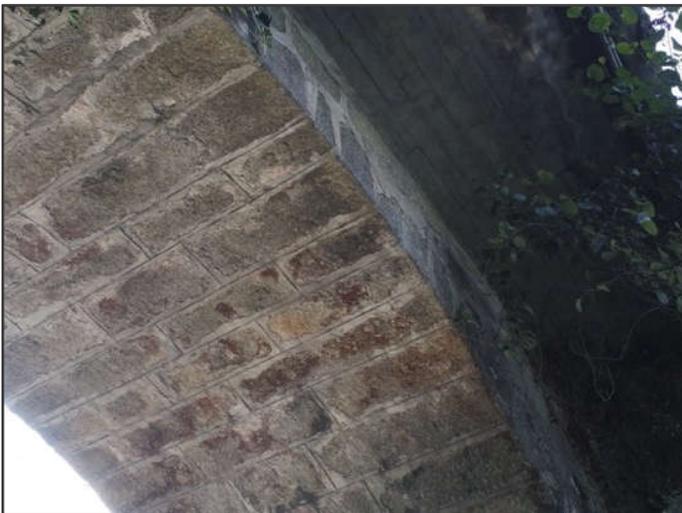
Fig. 9: Image captured with the quadcopter drone at the western start of the vault, where various injuries can be seen, such as dark scabs (photograph by the author).

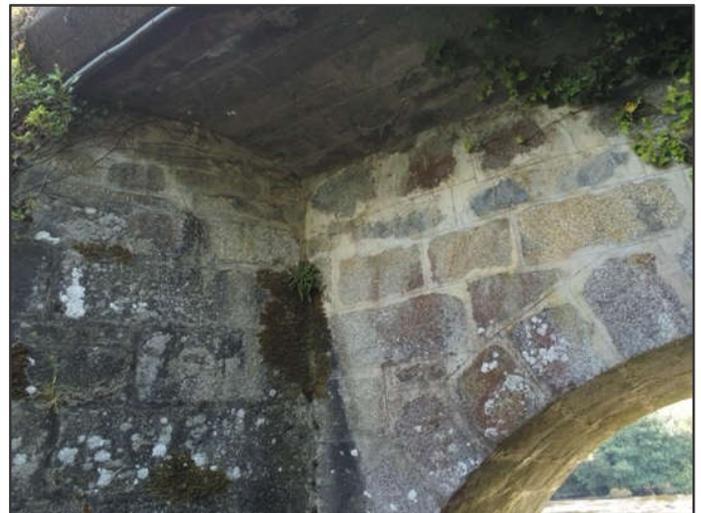
Fig. 12: Image captured with the quad copter drone, where you can see rooted vegetation in the joints of the ashlars and in the meeting edges (photograph by the author).

barely produce degradation (they only make the exterior look ugly), mosses in an alkaline environment (such as the environment created by lime or cement) can superficially degrade a centimeter or more of the rock. Lastly, the action of the plants is basically centered on the pressure that their roots produce between the ashlars of the masonry. This pressure can open cracks and even break blocks. In addition to these mechanical damages, plants can also produce chemical damage. In Ponte Oliveira, the plants have grown rooting in the joints that are arranged between the ashlars, especially in the joints of angular points (Fig. 12 and Fig. 13). This vegetation enters into feedback with the phenomena of humidity, efflorescence and runoff water, as reflected in the spots observed. Special care must be taken with vegetation, especially the larger ones, due to the action of tree roots and other plantations on the factory. In principle, the damages previously collected are not structural damages. They are damage related to the durability of the materials that make up the construction. In other words, they are not injuries that affect the integrity of the monument in the short term; however, they are injuries that can end up in more serious damage if they continue to develop. When we speak of damage related to the durability of the material that makes up an element, we refer to injuries that arise from the interaction of the deteriorated material with the environmental conditions imposed by it. In other words, the durability of the material must be understood as the ability of the material to resist the action of the environment. It includes all chemical, physical, biological attacks, or any other environmental process that tends to deteriorate the material. The discovery of efflorescence implies two important aspects: the first, that in some masonry a process of chemical degradation is taking place, in principle not very dangerous; the second, that, on the other hand, important internal mechanical stresses may be being generated due to the crystallization of the salt, depending on the porous system of the factory. The old and heritage buildings that are nearby are made of the same materials. This is due to the limitations of transport that existed in ancient times. The rocky substratum on which the south abutment rests justifies the above: its material is identical to that of the ashlars, although less altered.

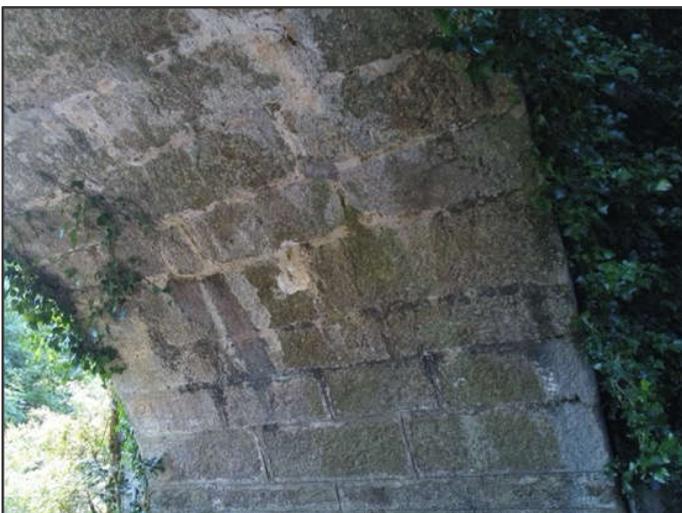
Fig. 10: Image captured with the quadcopter drone, where various lesions can be observed on the intrados of a vault, such as dark crusts or organic matter (photograph by the author).

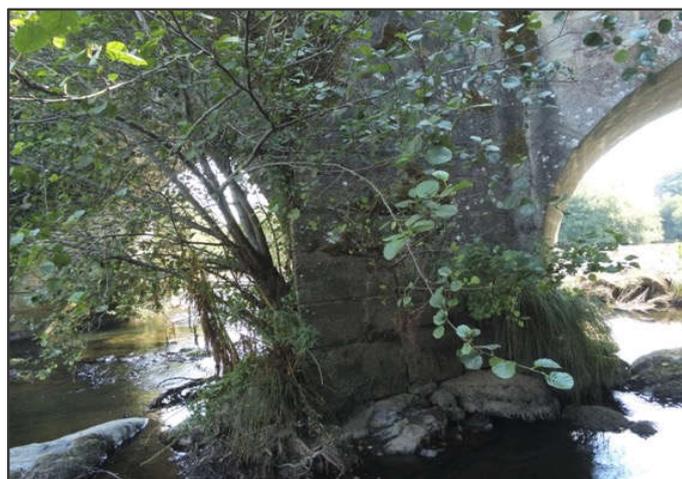
Fig. 13: Image captured with the quadcopter drone, where we can see abundant vegetation rooted on the first pier (photograph by the author).
