USE OF RPAS (DRONES) FOR OLD BRIDGES INSPECTION: APPLICATION ON PONTE OLVEIRA BRIDGE

*Rodríguez Elizalde, Rubén

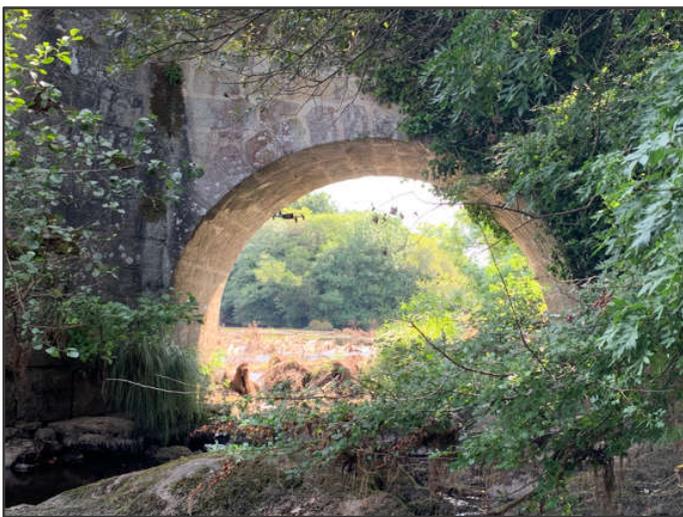
Fig. 6: Drone approaching the smaller Ponte Oliveira bridge arch vault for its inspection (photograph taken by the author).
